CEEDO-TR-78-16

Evaluation of Materials for Post-Attack Pavement Repair

U. S. ARMY ENGINEER WATERWAYS EXPERIMENT STATION
GEOTECHNICAL LABORATORY
P.O. BOX 631, VICKSBURG, MISS. 39180

SEPTEMBER 1978

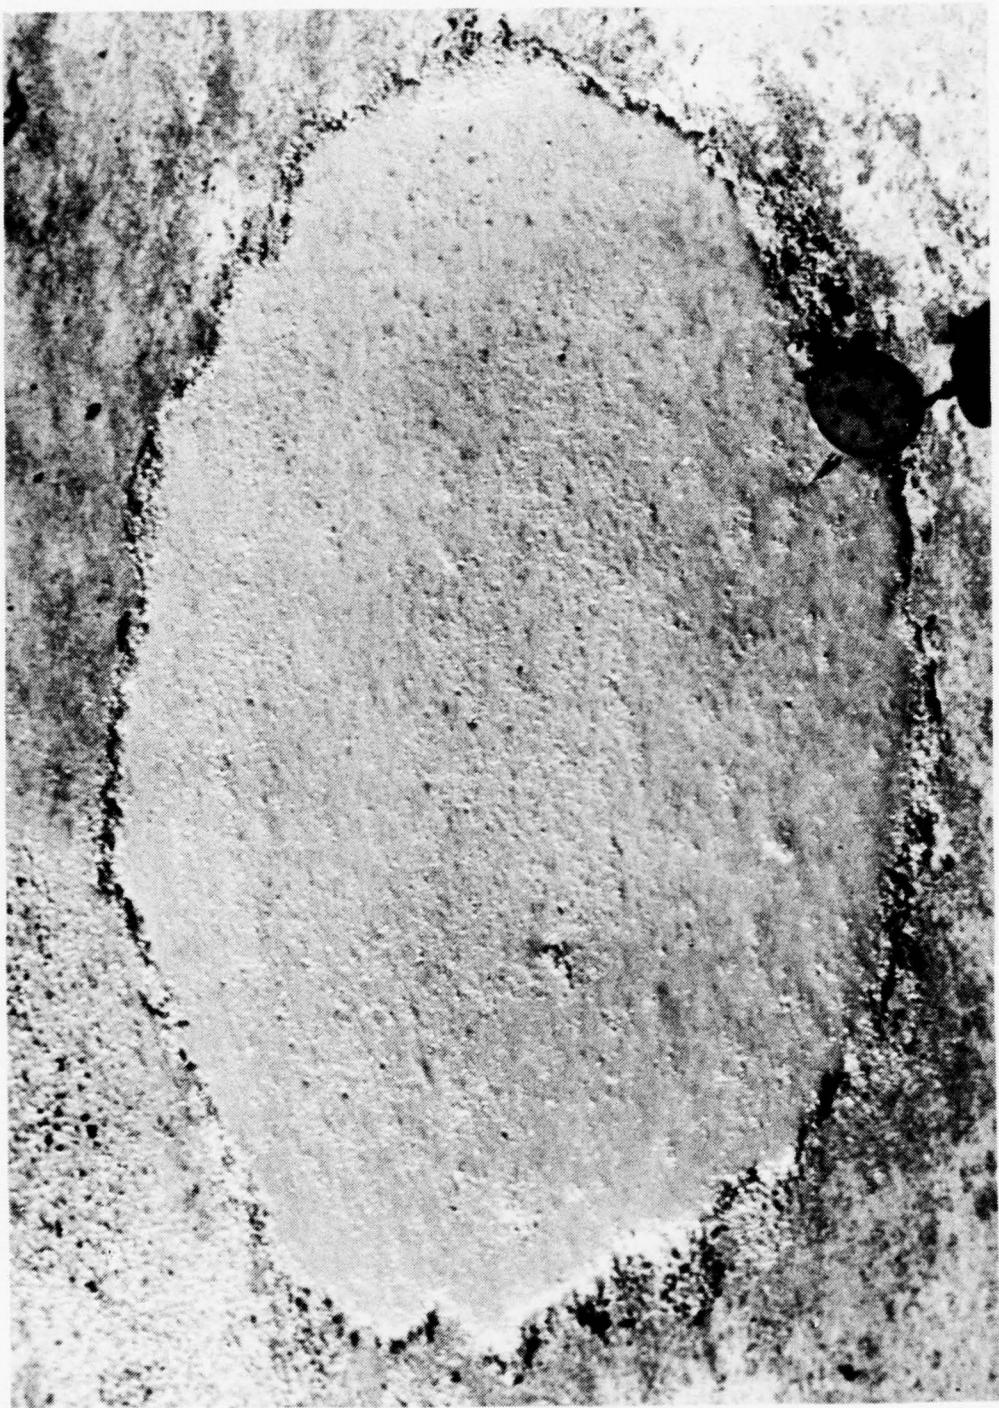
Traffic was applied to the repaired areas 42 minutes after placing. No damage was noted after 20 coverages (192 passes in 10-foot-wide traffic lane) as shown in Figures 13 and 14 for 2- and 5-foot repair area, respectively.

Figure 13. Surface of Darex 240 in 2-Foot-Diameter Area After 20 Coverages

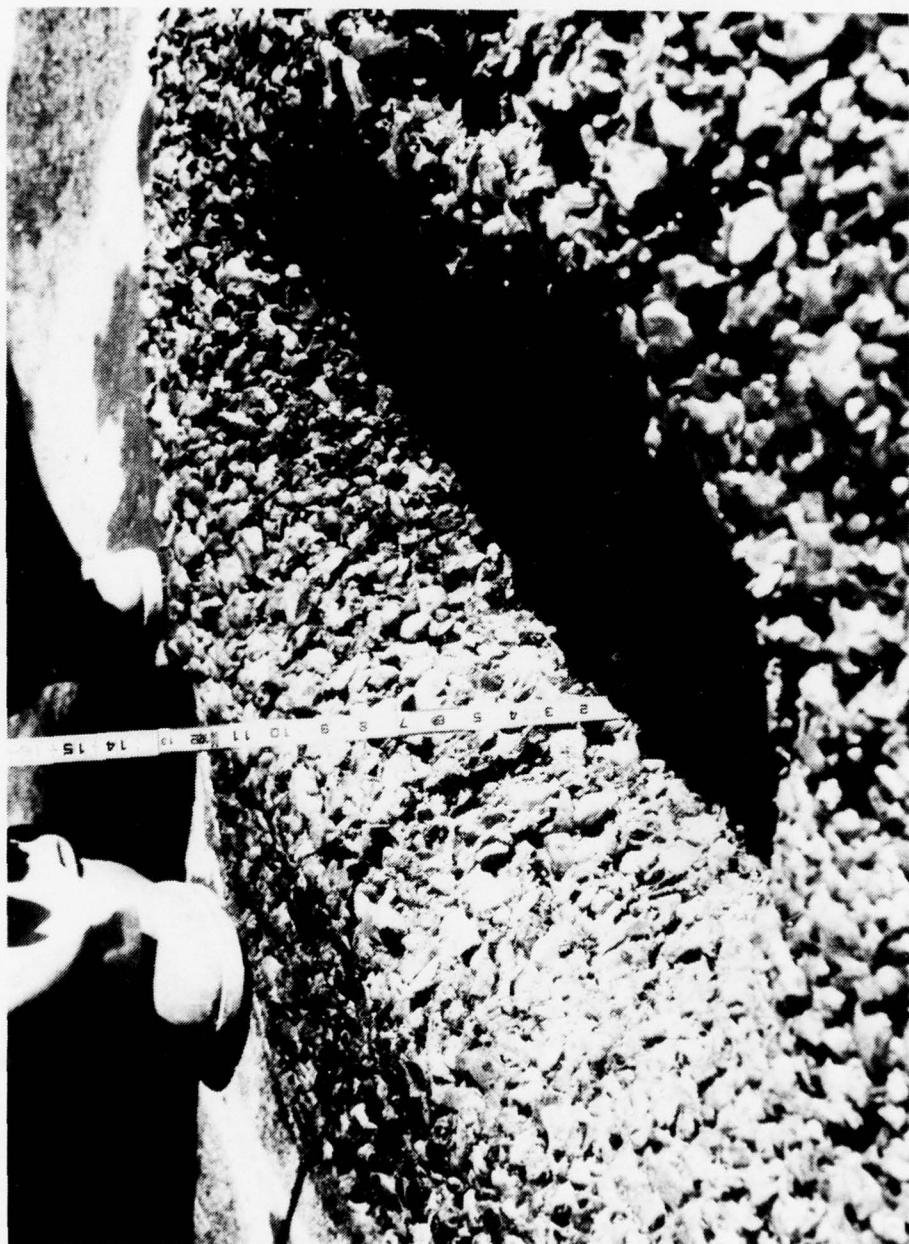
areas 34 minutes after the last batch of Hathane 1600A had been poured over the gravel. The material would not support the load wheel and failed on the first pass. The failure developed by the load wheel is shown in Figure 25. The failed area was repaired by shaping the areas with hand tools and compacting with a mechanical tamper. After 30 minutes additional time, the material would support the load wheel, but deformation of approximately 3 inches occurred in the 5-foot-diameter area as the load wheel moved across.

Figure 25. Failure Developed on First Pass of Load Wheel in
Hathane 1600A

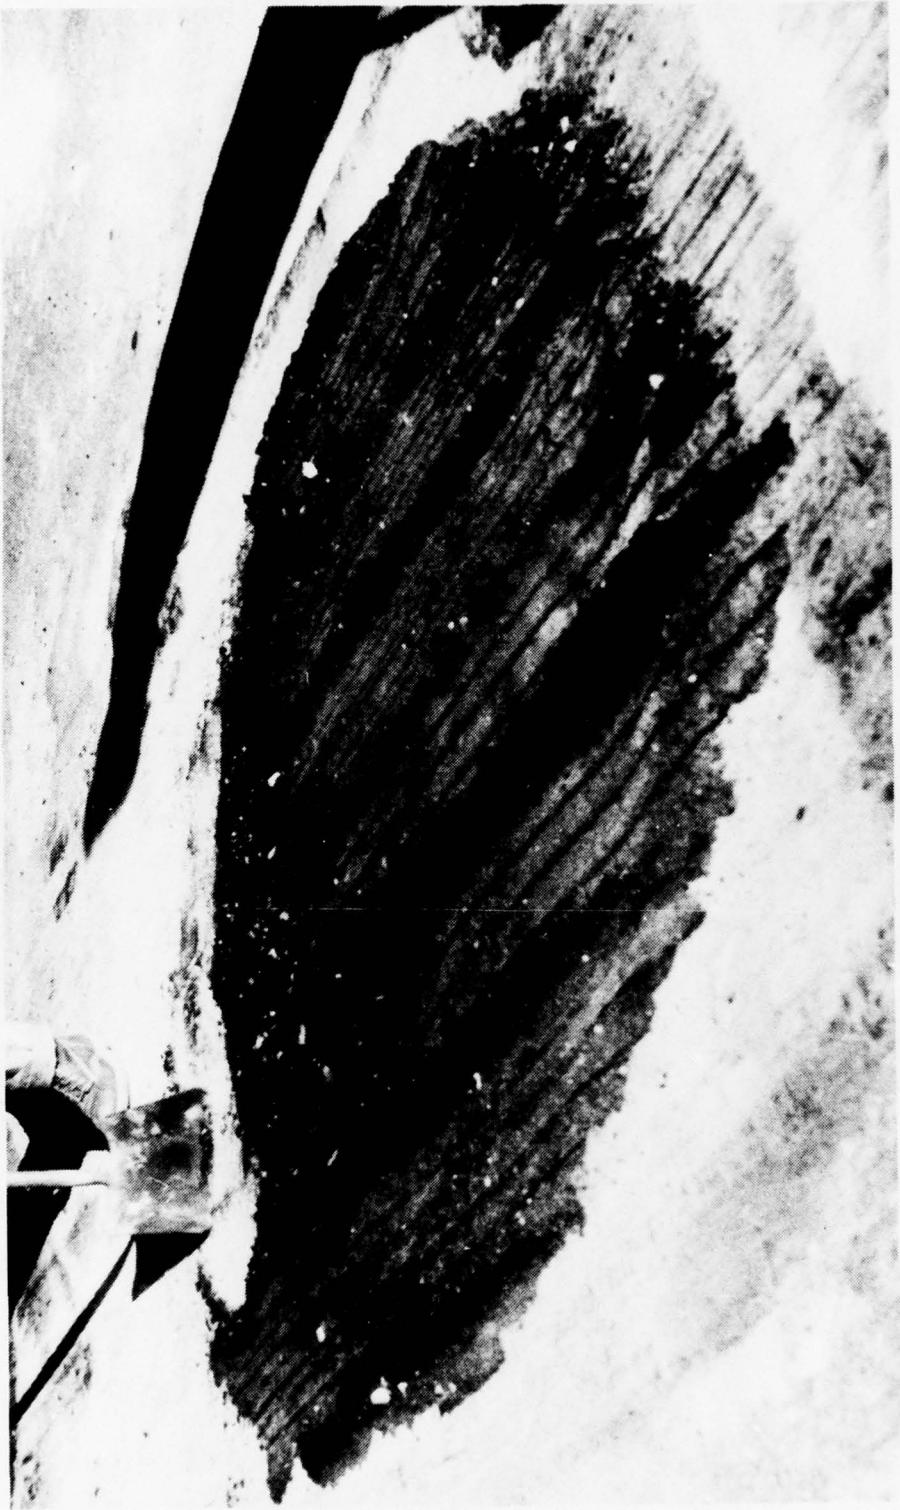
Traffic was applied immediately after cold mix was placed and compacted. The cold mix rutted under each pass of the load wheel; and after two coverages, the 5-foot-diameter area was repaired by leveling and placing material that had worked out of the area back in the test area (see Figure 32) and compacting with the mechanical tamper. After two more coverages, ruts of approximately 2 inches deep had developed in the 5-foot-diameter area as shown in Figure 33, but the 2-foot-diameter area was in fair condition. Traffic was terminated after four coverages due to rutting in the 5-foot-diameter area. An examination of the base course showed no signs of failure in the crushed limestone base course.

Figure 32. Repairing Cold Mix No. 1 in 5-Foot-Diameter Area After
Two Coverages

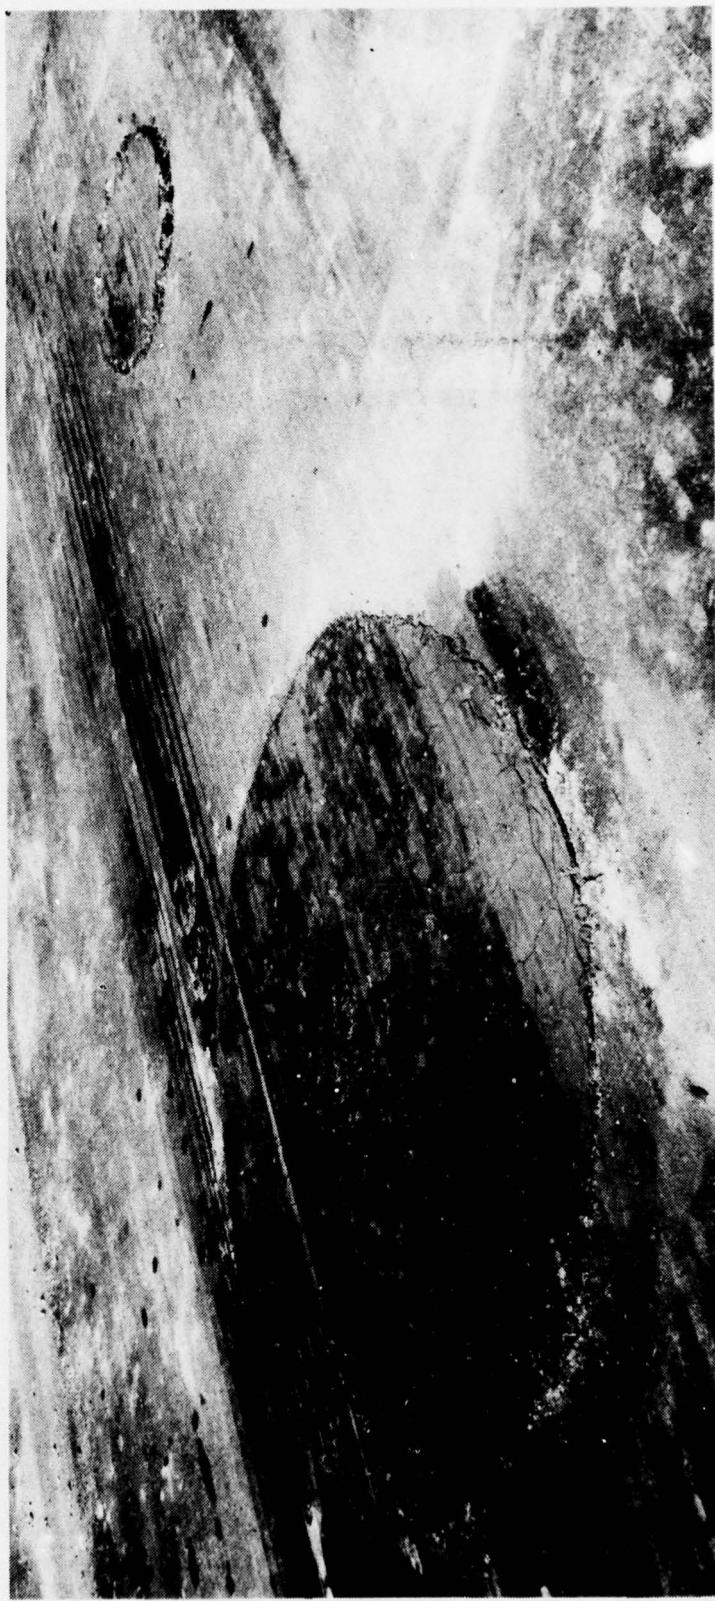
Traffic was applied to the repaired areas 29 minutes after the last batch of polyester resin was placed. During traffic, polyester resin at the surface of the 2- and 5-foot areas cracked and loose particles were noted. The 2-foot-diameter area did not bond to the sides of adjacent pavement, and movement of the patch was noted during traffic. After 10 coverages, the 2-foot-diameter area was completely loose from adjacent pavement. Figure 39 shows the condition of the 2-foot- and 5-foot-diameter areas after 10 coverages. The 8-foot-diameter area did not have as thick a film of polyester resin without aggregate at the surface as the 2-foot- and 5-foot-diameter areas, and a less number of loose particles was noted after 10 coverages of traffic. Figure 40 shows the condition of the surface of the 8-foot-diameter area after 10 coverages.

Figure 39. Surface of Polyester Resin in 2-Foot- and 5-Foot-Diameter Areas After 10 Coverages

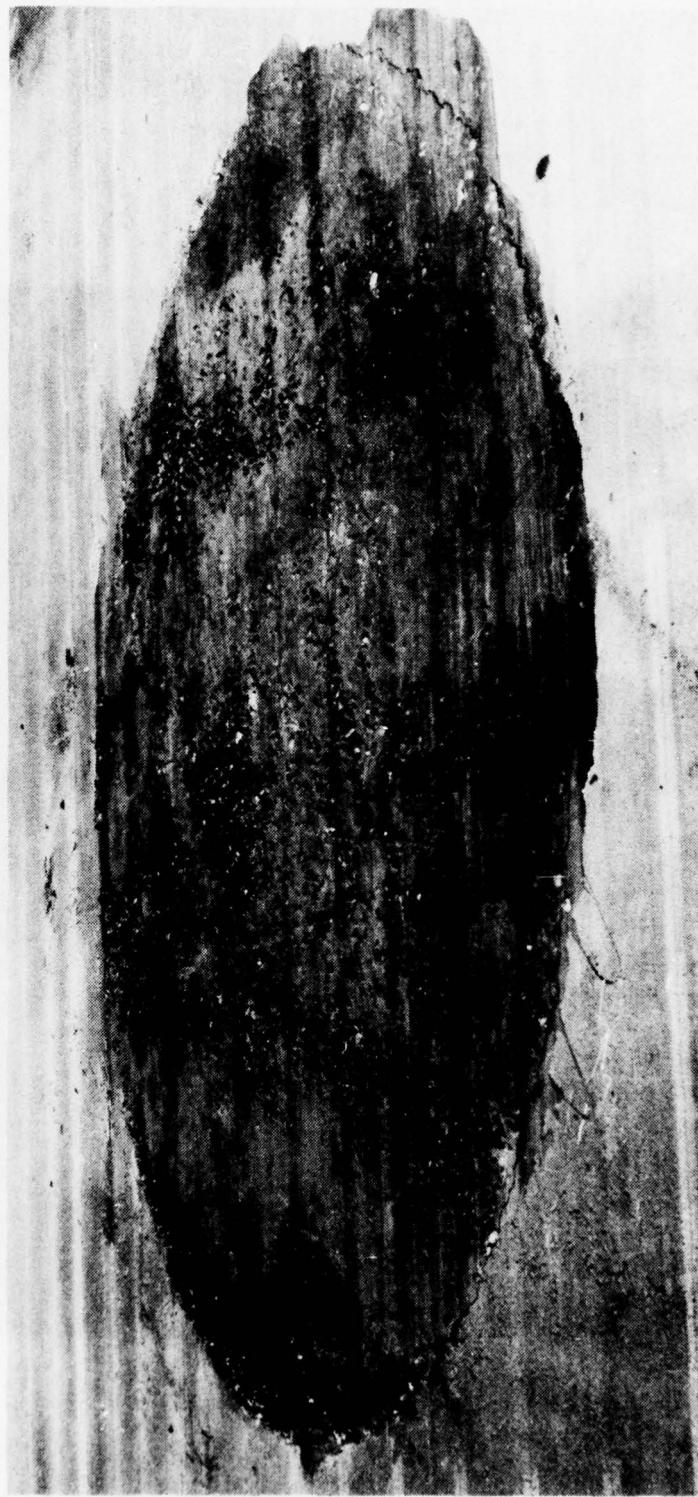
Figure 40. Surface of Polyester Resin in 8-Foot-Diameter Area After
10 Coverages

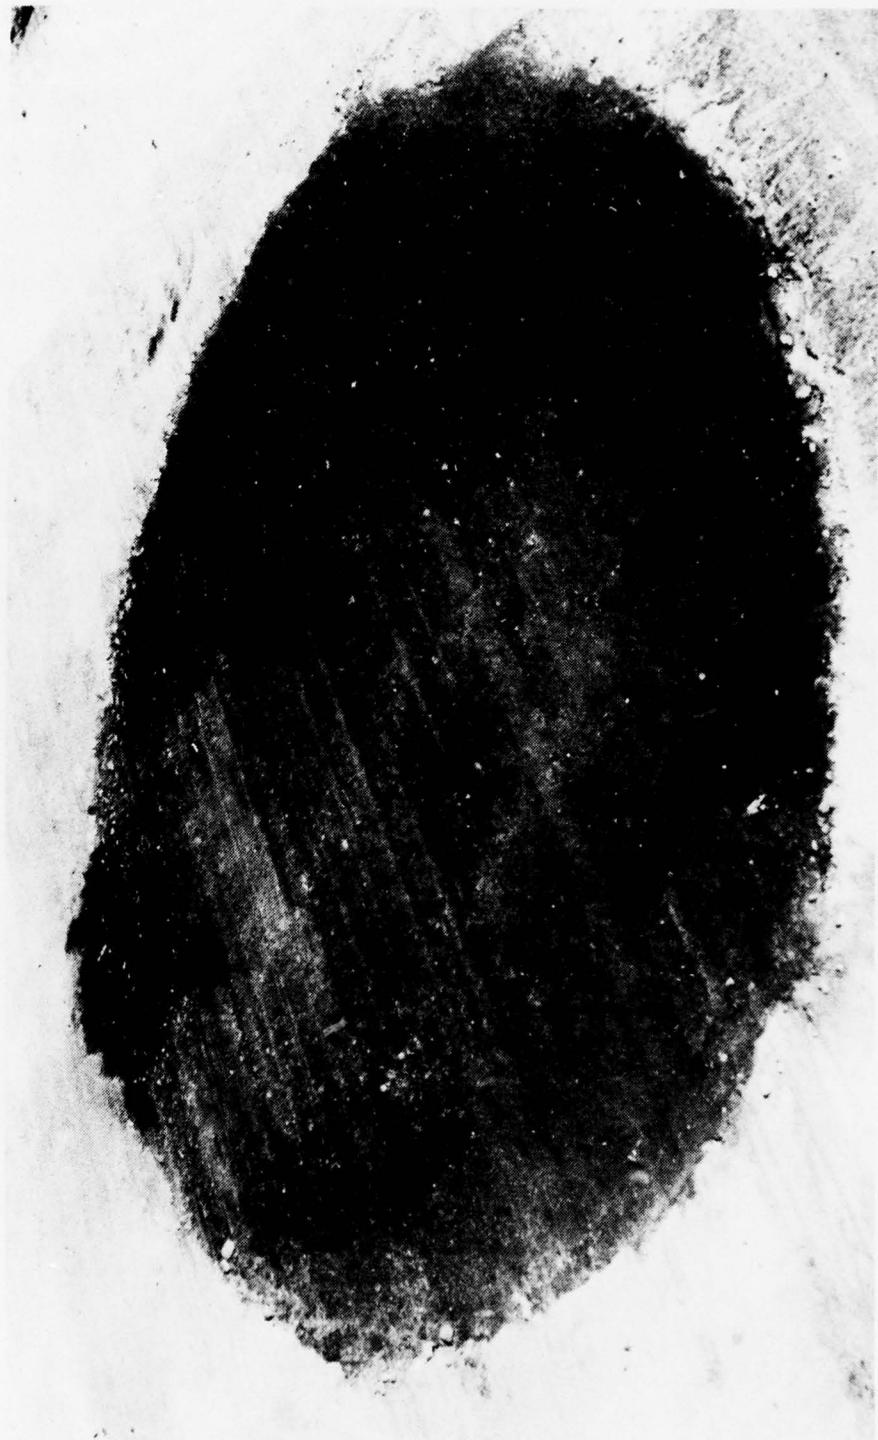
Traffic was applied to the repaired area 66 minutes after placing. Twenty coverages were applied with no sign of failure. The condition of the repaired area after 20 coverages is shown in Figure 43.

Figure 43. Surface of Fondu Concrete After 20 Coverages

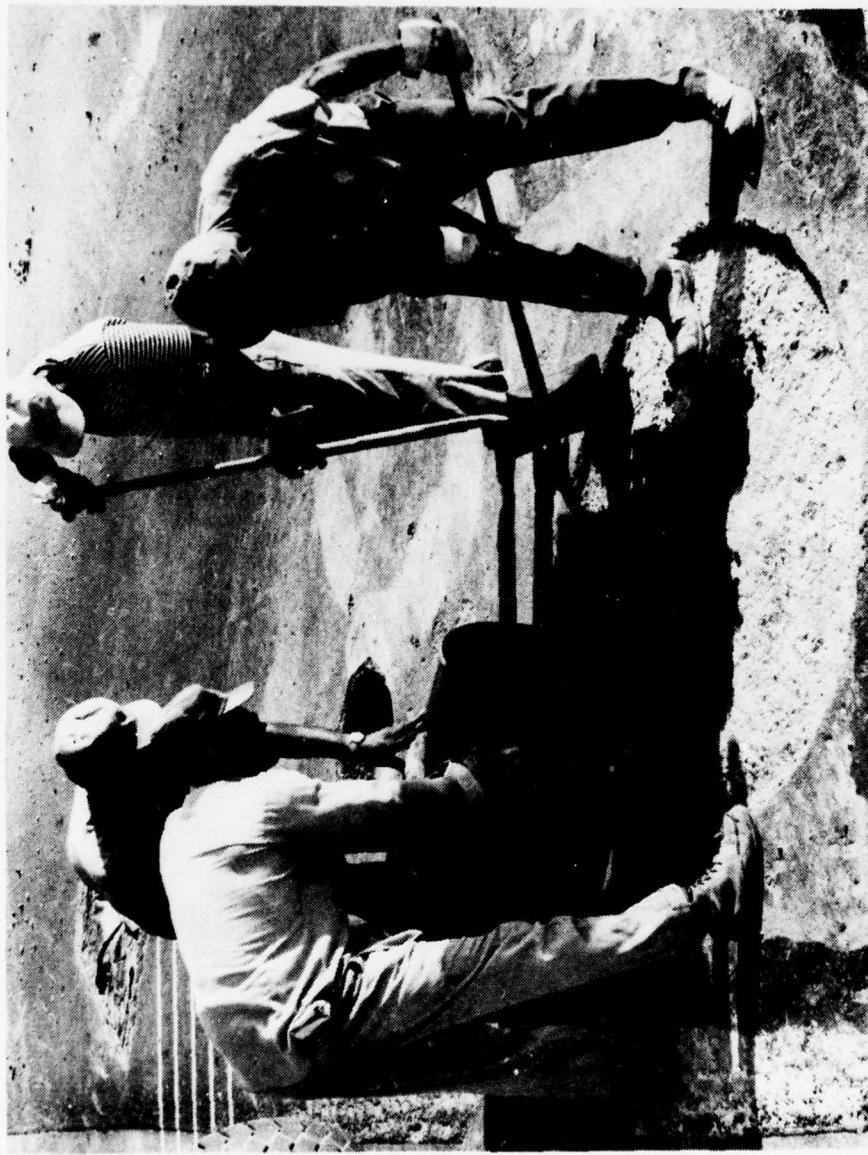
Figure 50. Placing Future Patch in 5-Foot-Diameter Area

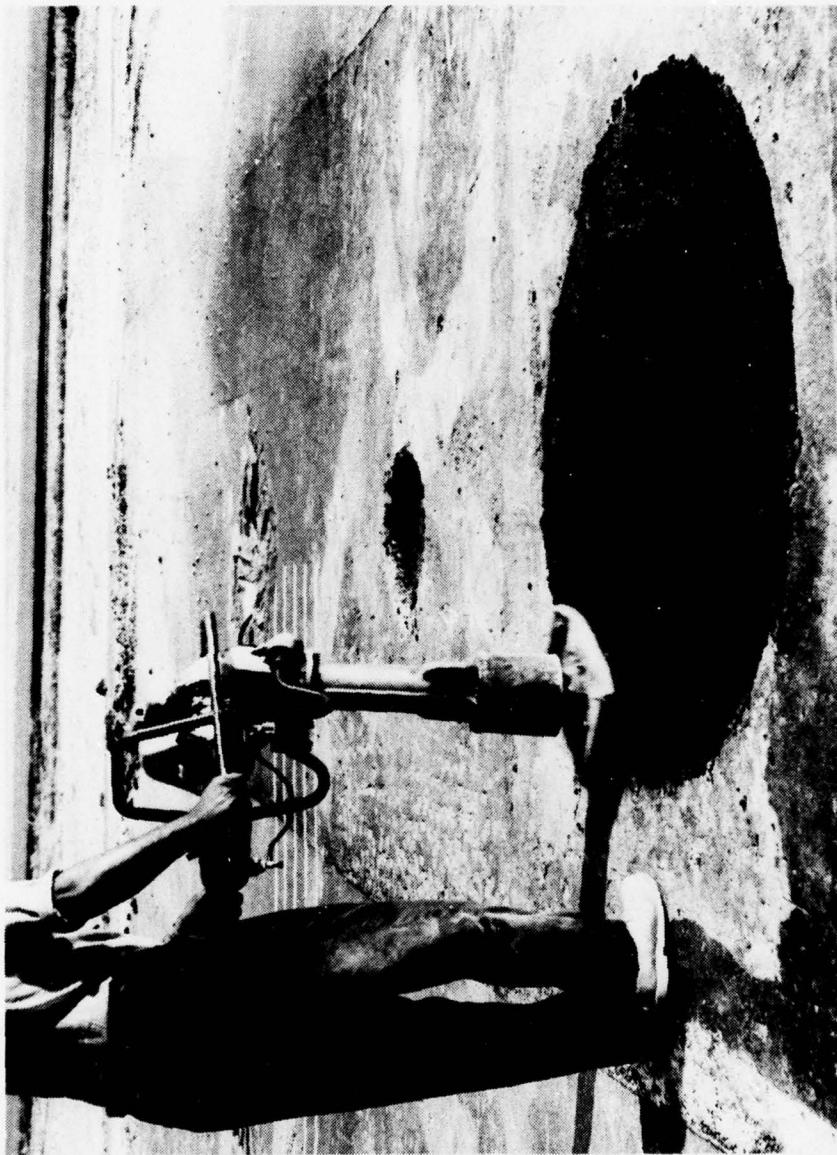
Figure 51. Compacting Future Patch with Mechanical Tamper

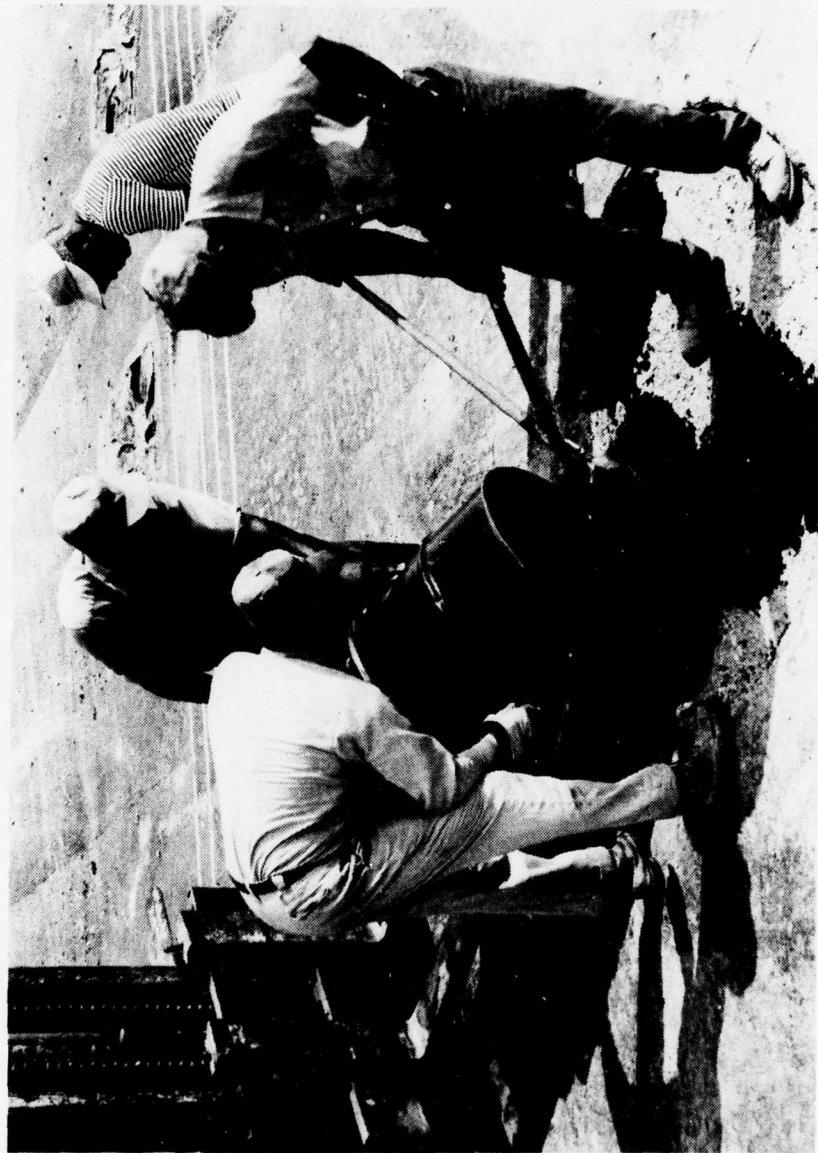
Figure 53. Placing Sylvax in 5-Foot-Diameter Area

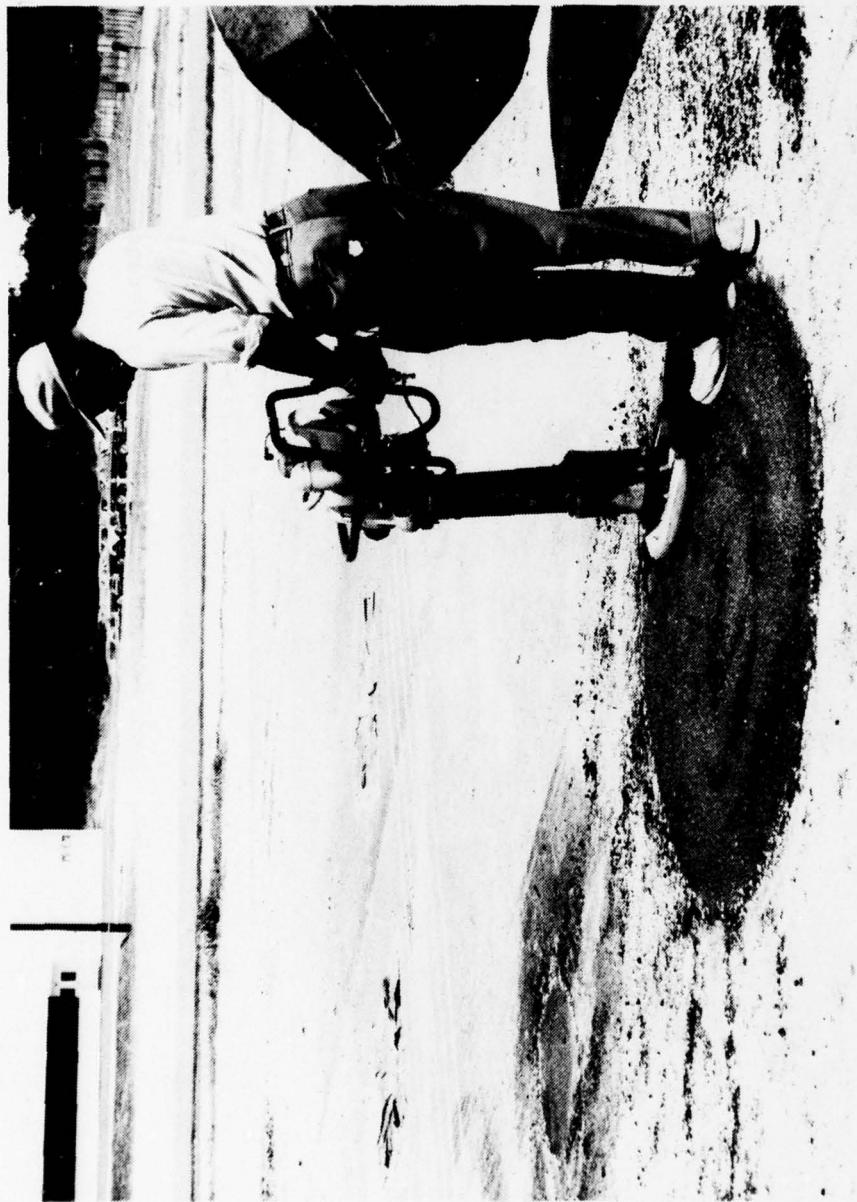
Field-mixed Amalgapave was used to repair 2-foot- and 5-foot-diameter areas in flexible pavement. A compacted crushed limestone base course was placed to within 1 inch of the pavement surface in the 5-foot-diameter area by the same procedures as in other flexible pavement repairs. The field-mixed Amalgapave was placed and compacted in one lift in the 5-foot-diameter area and in two lifts in the 2-foot-diameter area. Compaction was accomplished with a mechanical tamper as shown in Figure 55.

Figure 55. Compacting Field-Mixed Amalgapave with Mechanical Tamper

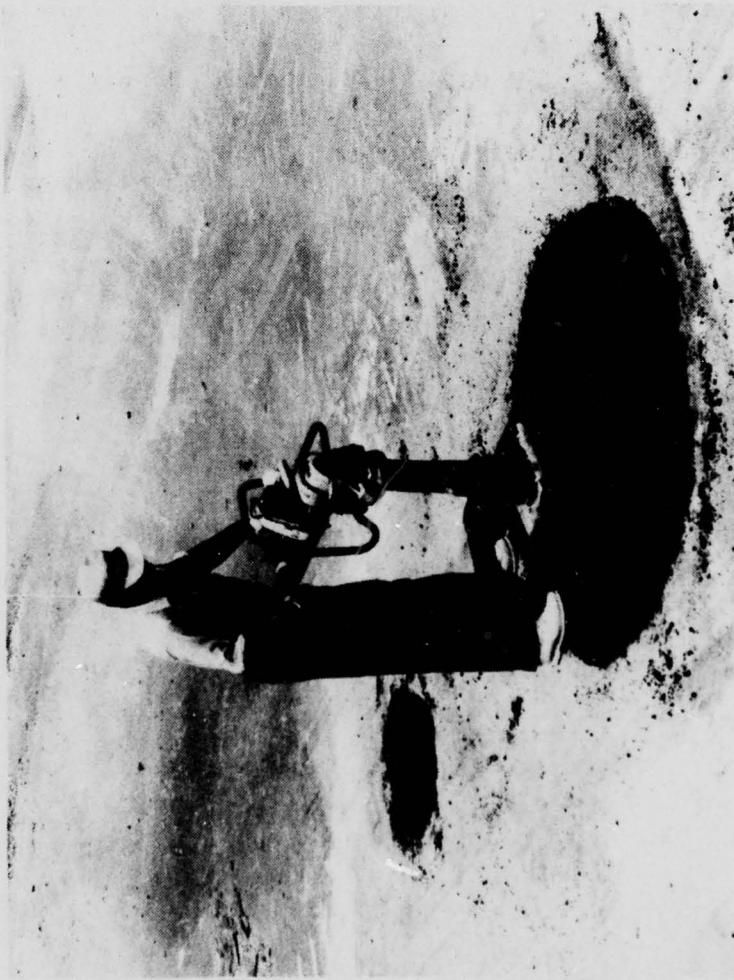
Field-mixed cold mix was used to repair 2-foot- and 5-foot-diameter areas in flexible pavement. Crushed limestone base course was placed and compacted in the 5-foot-diameter area to within 1 inch of the pavement surface. Methods of placing and compacting base course were the same as used for other flexible pavement repairs. The field-mixed cold mix was placed and compacted in one lift in the 5-foot-diameter area and in two lifts in the 2-foot-diameter area. Compaction was accomplished with a mechanical tamper as shown in Figure 57.

Figure 57. Compacting Field-Mixed Cold Mix with Mechanical Tamper

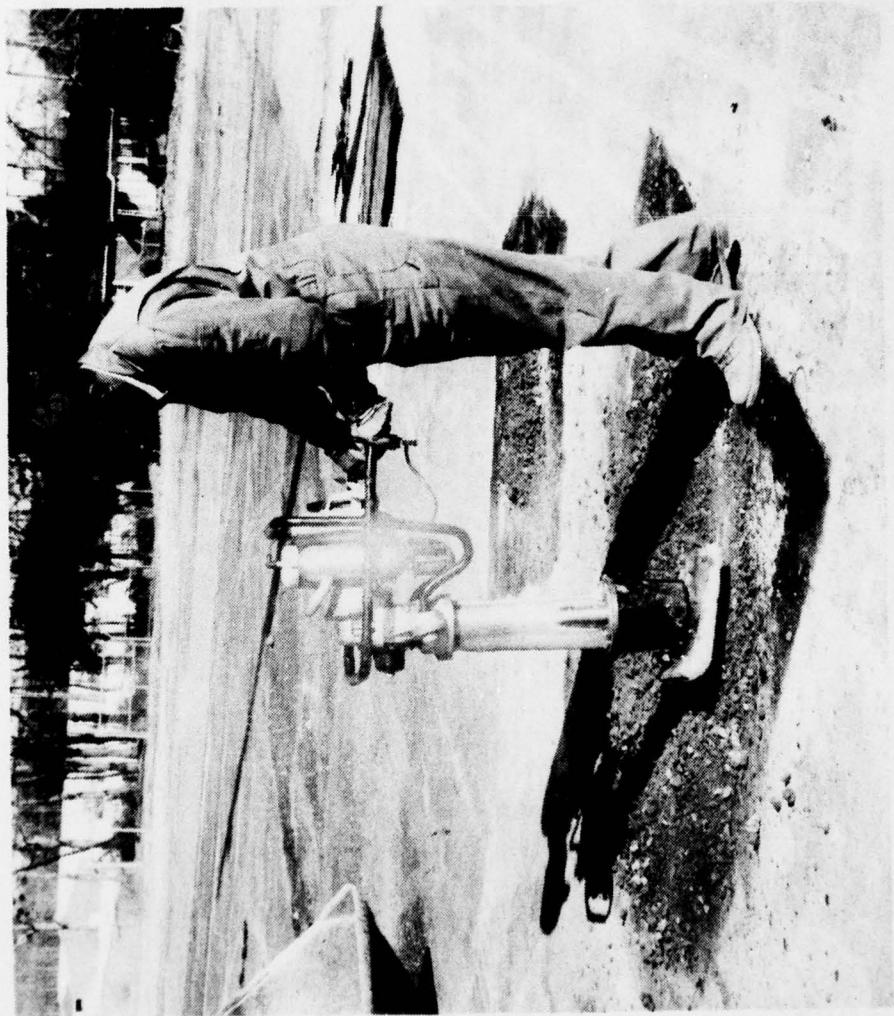
with a front-end loader by picking it up and turning it over several times, spreading in a uniform layer, and adding water, as shown in Figure 60, to bring the water content up to optimum for the crushed limestone. After water was added, material was remixed with the front-end loader. The mixture was placed in each area in two lifts, and each lift compacted with a mechanical tamper as shown in Figure 61. The surface of the mixture was sprinkled with water during final compaction.

Figure 61. Compacting Mixture of Crushed Limestone and Portland Cement with Mechanical Tamper

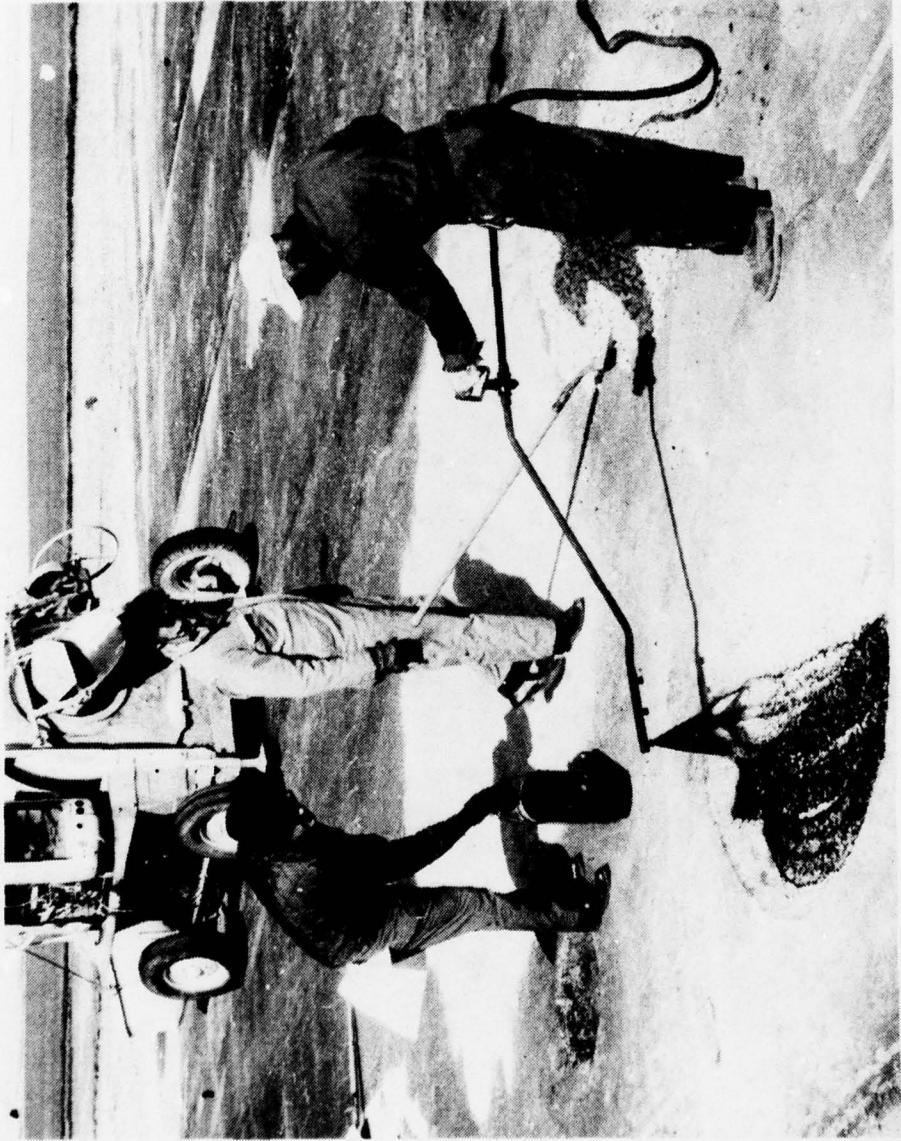
Figure 63. Spraying Asphalt Cement on Base Course Prior to Placing
Macadam Repair

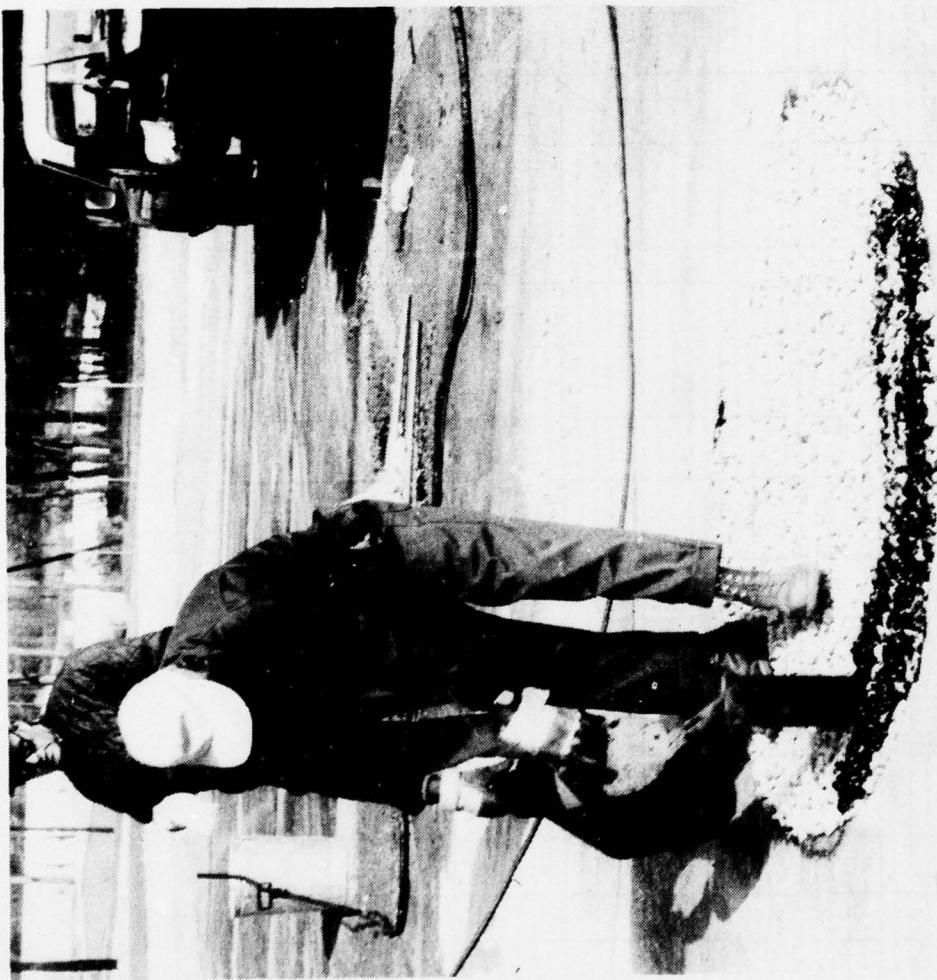
Figure 65. Pouring Hot Asphalt Cement Over Coarse Aggregate in
Asphalt Macadam Repair

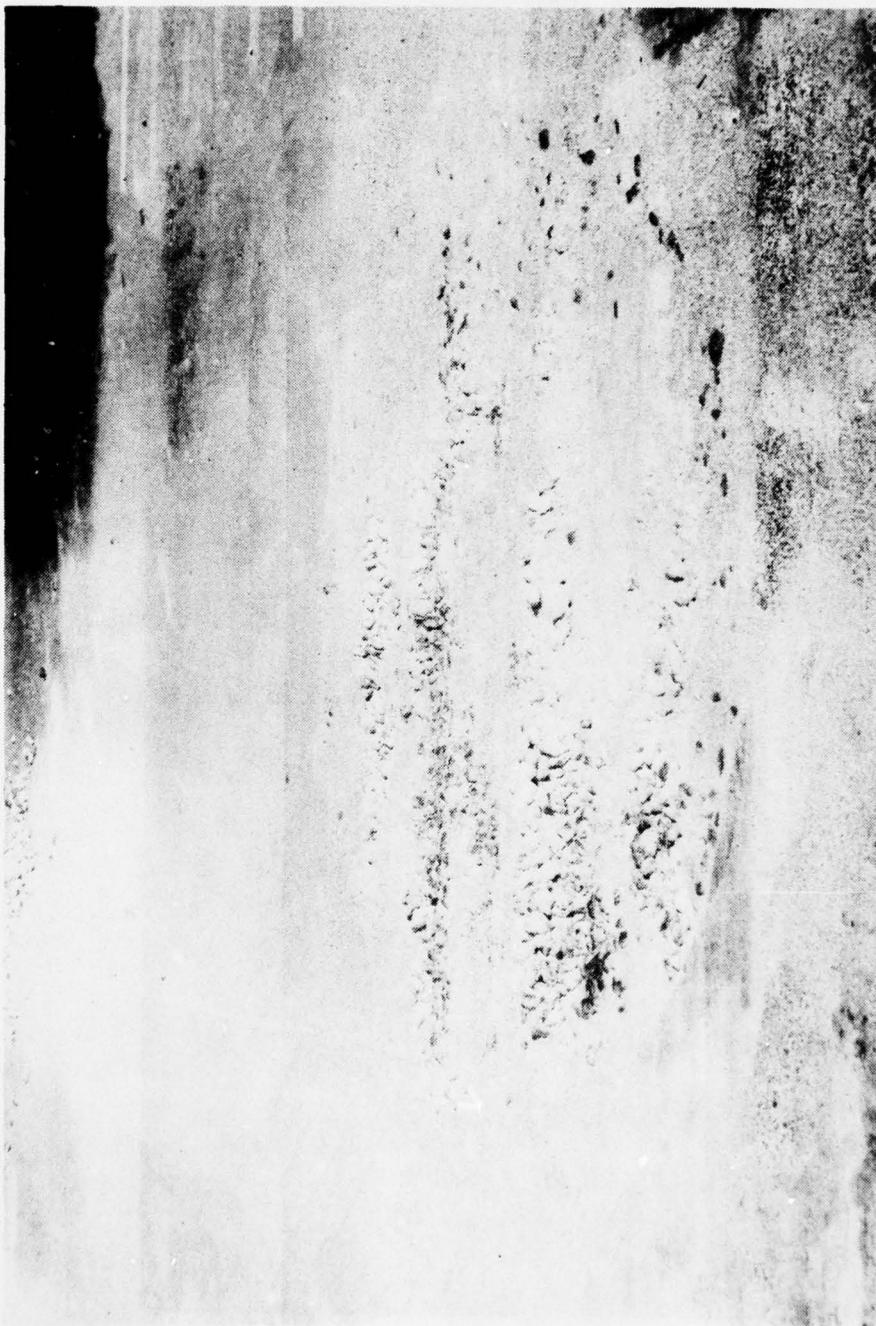
14. Asphalt Macadam was not satisfactory due to lack of stability. This type repair would require time for heating asphalt at any time and during cold weather would be difficult to place because of asphalt cooling in applicator lines.

Figure 68. Condition of Asphalt Macadam After Eight Coverages

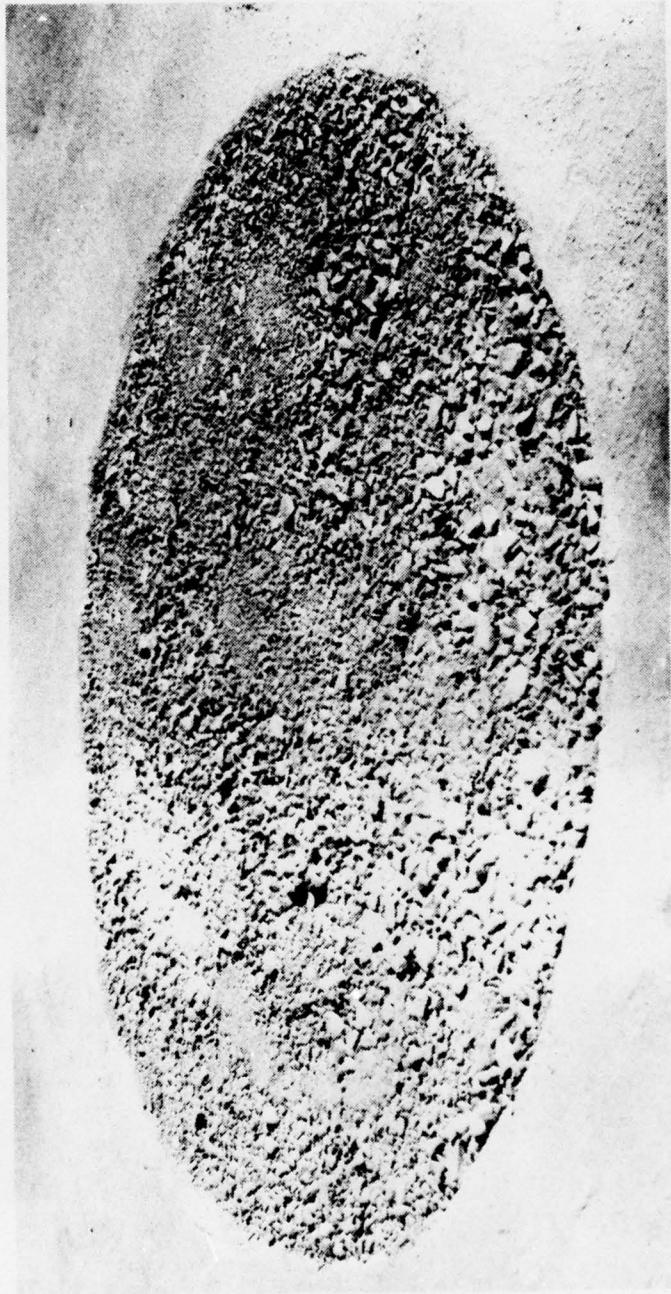
This material was used to repair a 5-foot-diameter area in flexible pavement. The area was filled with compacted crushed limestone placed and compacted in two lifts with a mechanical tamper. The surface of the finished base course material is shown in Figure 70. The 6-foot-square asphalt-saturated polyester fabric was placed over the repaired area and crushed limestone fine aggregate spread over the surface. The fabric was heated with a propane torch and rolled with a 30-ton pneumatic-tired roller with 90 psi tire pressure as shown in Figure 71. The finished surface of the repaired area prior to traffic is shown in Figure 72.

Figure 70. Finished Surface of Base Course in Asphalt-Saturated Felt Repair Area
